# QUALITY ASSURANCE(QA) FOR ELEKTA KILOVOLTAGE CONE BEAM COMPUTED TOMOGRAPHY (CBCT) IN UHC SPLIT

M.Todorović, K.Vrcan,A. Karin, D.Hrepić

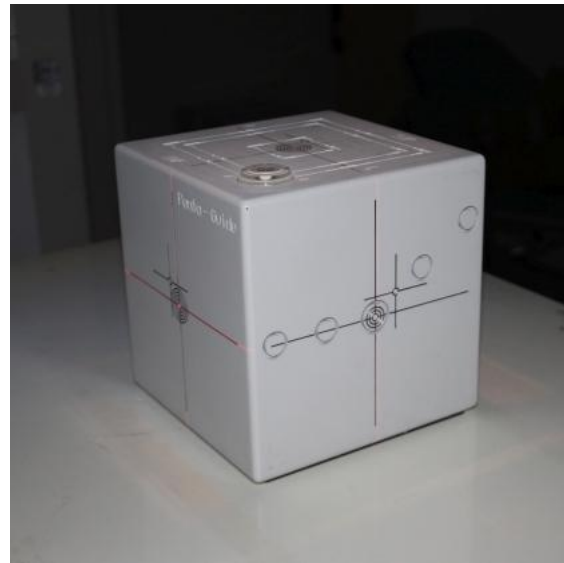
# GEOMETRIC ACCURACY TEST

- For daily checks the kV CBCT isocenter use the room lasers and Penta Guide phantom.

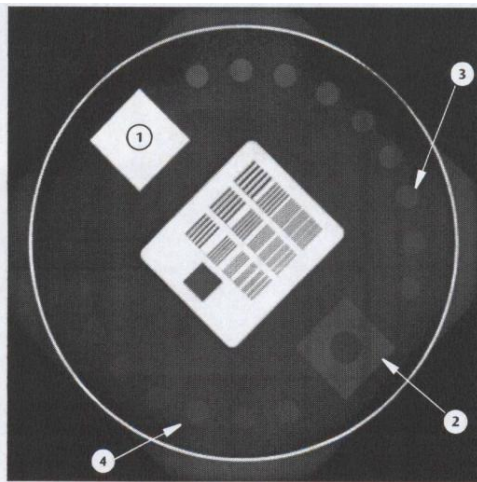
### ○ 2D Low contrast visibility with TOR 18FG

- 1-Brightness indicator
- 2-Contrast indicator
- 3,4-Low contrast disks

The more disks you can see, the better the low contrast visibility!

Comparison with initial (acceptance) test.

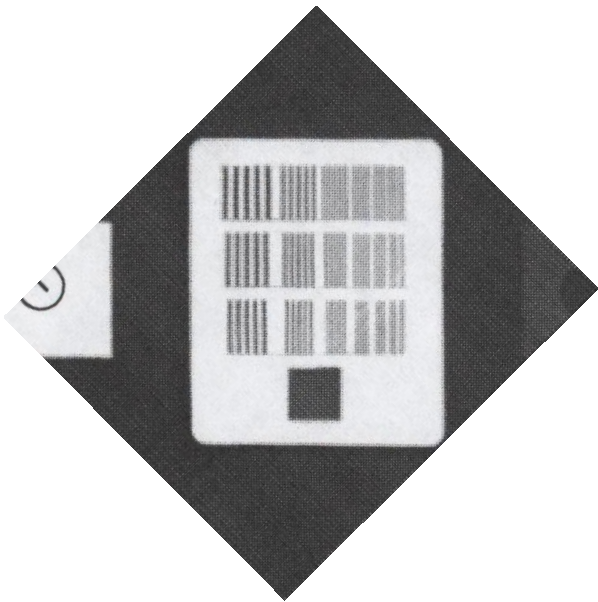
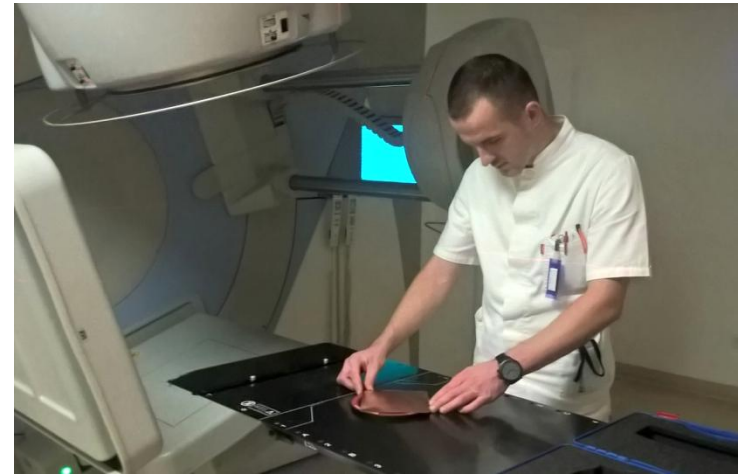
- 2D Spatial resolution in lp/mm (TOR 18FG)

Count the groups from the top left down, then the group in other columns down.

Comparison with initial (acceptance) test.

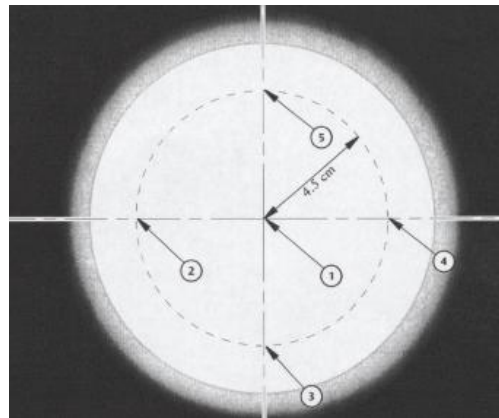
- 3D uniformity with Catphan CTP 600  
Scans in uniformity module and image analysis

Analysis area:

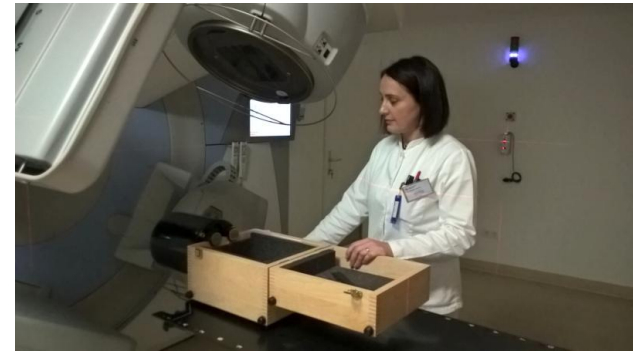
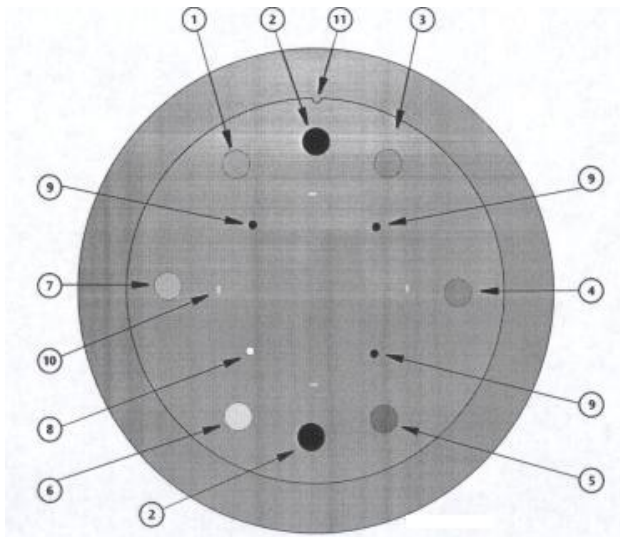
## 3D low contrast visibility

Scans in contrast resolution module and image analysis

Analysis area for mean pixel value and st.dev.:

- (1) Acrylic
- (2) Air insert
- (3) Polystyrene insert
- (4) LDPE insert
- (5) PMP insert
- (6) Teflon insert
- (7) Delrin
- (8) Teflon rod
- (9) Air rods
- (10) White alignment markers
- (11) Keyway

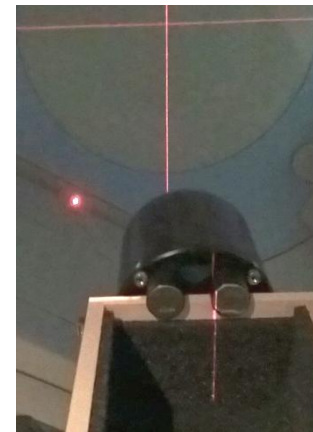
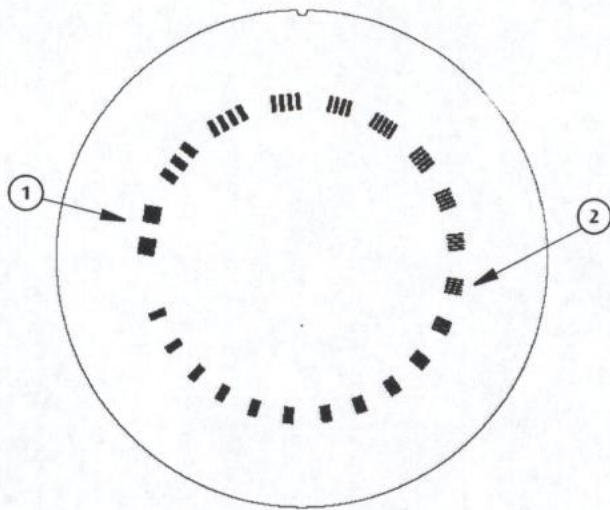
## ○ 3D spatial resolution

Scans in spatial resolution module and image analysis

Analysis area for count number  
line pair :

(1) Line pair 1

(2) Line pair 10

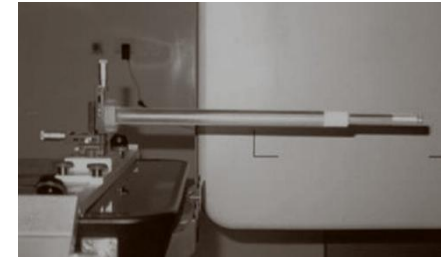
# 2D GEOMETRIC ACCURACY TEST

- Difference between MV and KV isocenter with Ball-bearing phantom

Scan and results in XVI:

Use MV planar view of the different gantry angles ( $0^\circ$ ,  $90^\circ$ ,  $180^\circ$  and  $270^\circ$ ) for MV isocenter.

Compare MV and XVI isocenter.

Tolerance: 1mm

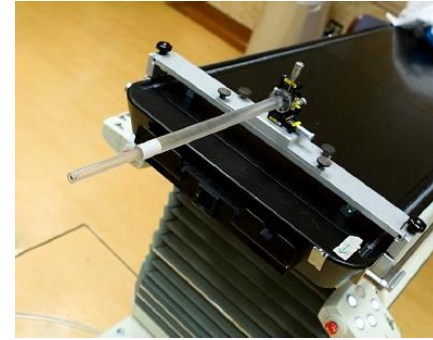
# TABLE MOVE ASSISTANT ACCURACY TESTS

- Test for Table Move Assistant (TMA) in Elekta XVI system with Ball-bearing phantom

Use 15mm offset in Lat., Long. and Height and use functions “Automatic Registration” and “Convert to correction” on XVI

Results:

Tolerance: 2mm

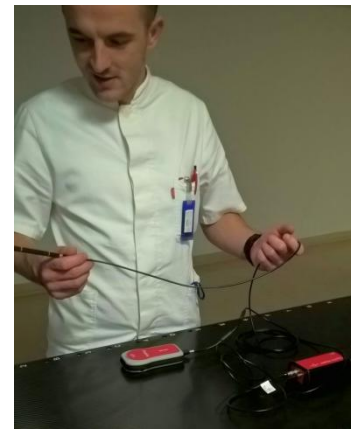
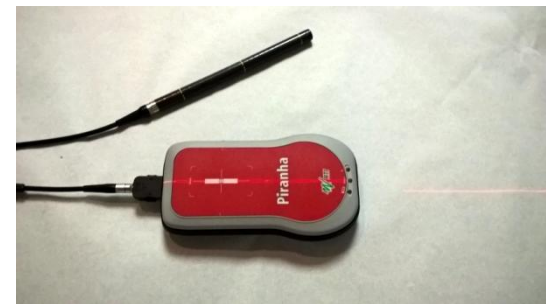
# DETERMINATION OF DOSE

- $CTDI_{100}$  with Piranha multimeter,  $3\text{ cm}^3$  and 100mm ionization chamber and CT cylindrical phantom

10 cm CBCT scans for each of position chambers in the phantom.

Comparison with initial tests.

Tolerance: 20%
